Sekai Walls  
ID: 1254661

Master Thesis explanatory document  
Dr. Christoph Schnoor & Tony van Raat

An explanatory document submitted in partial fulfillment of the requirements of the degree for the Master of  
Architecture (Professional) at Unitec, New Zealand 2013.

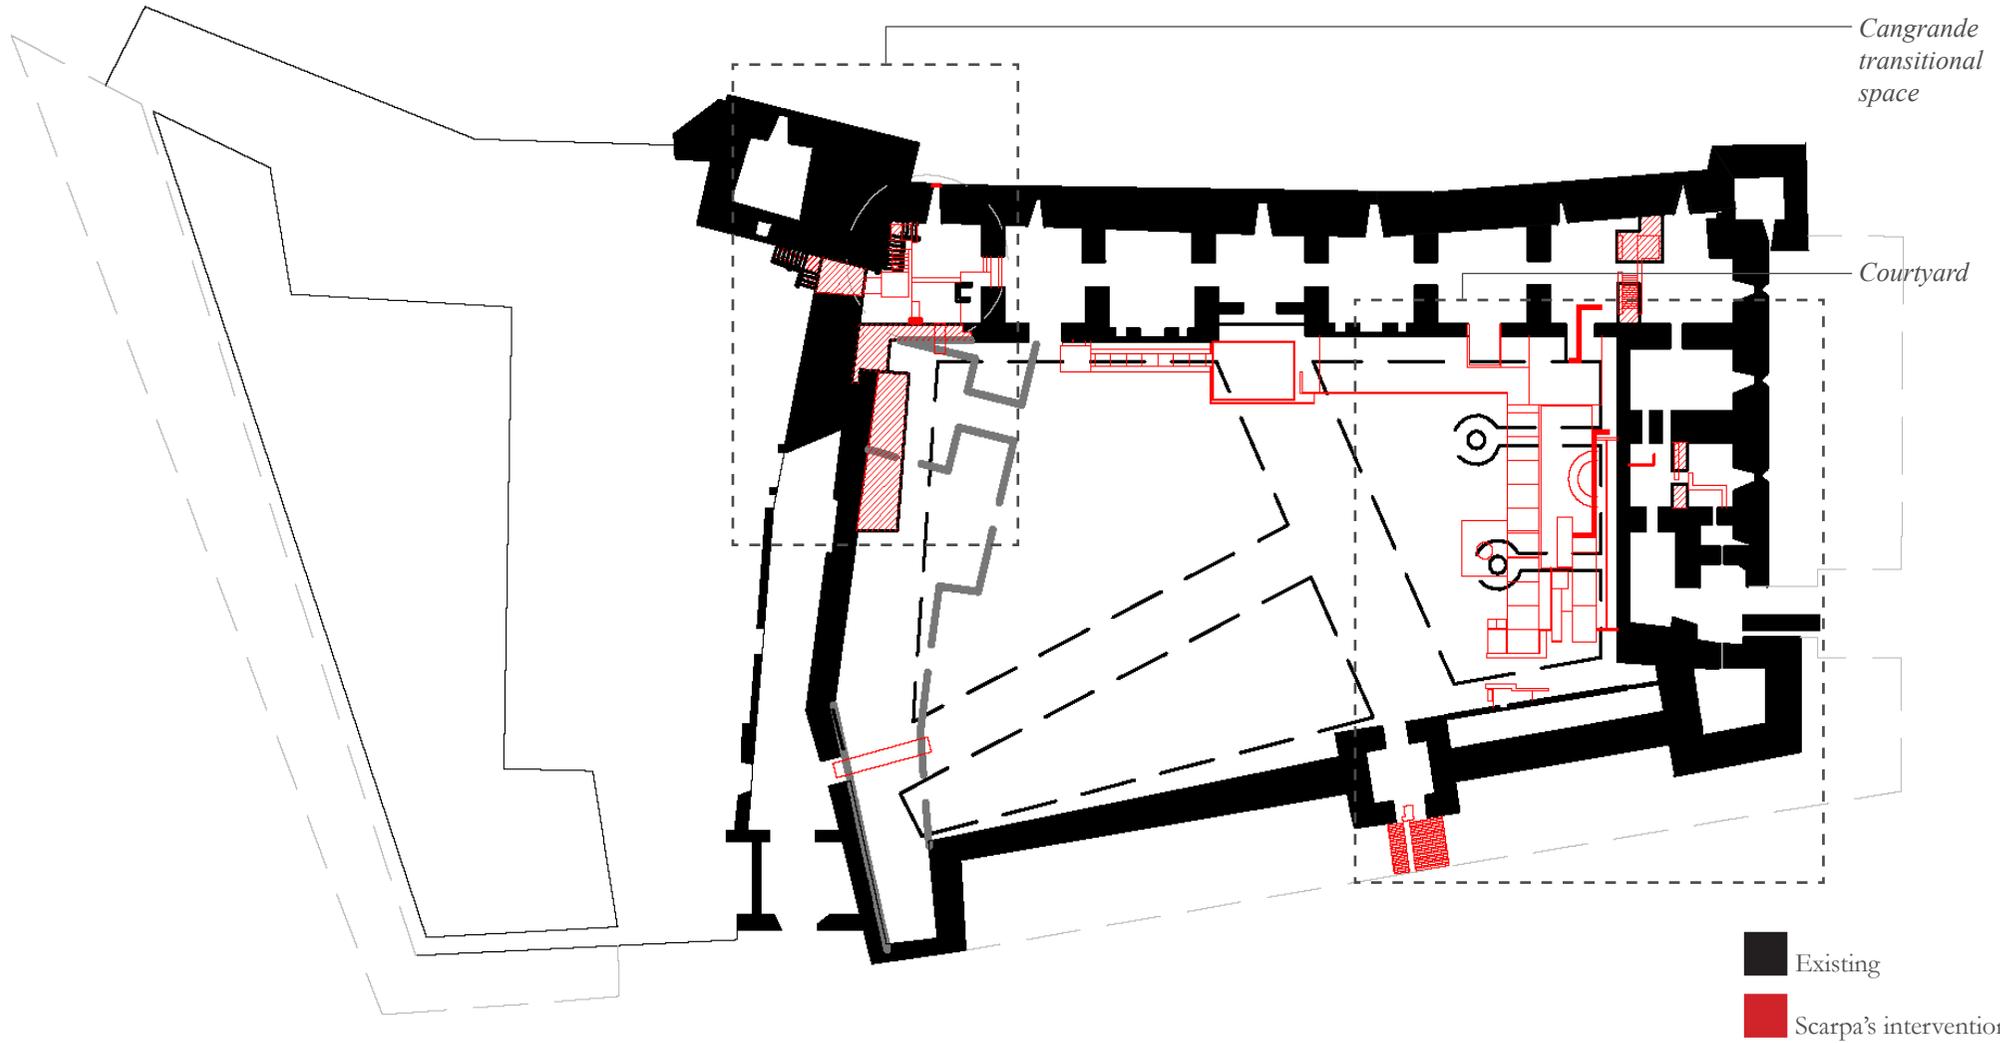
Fig 14 Plan of the Castelvecchio after Scarpa's restoration.

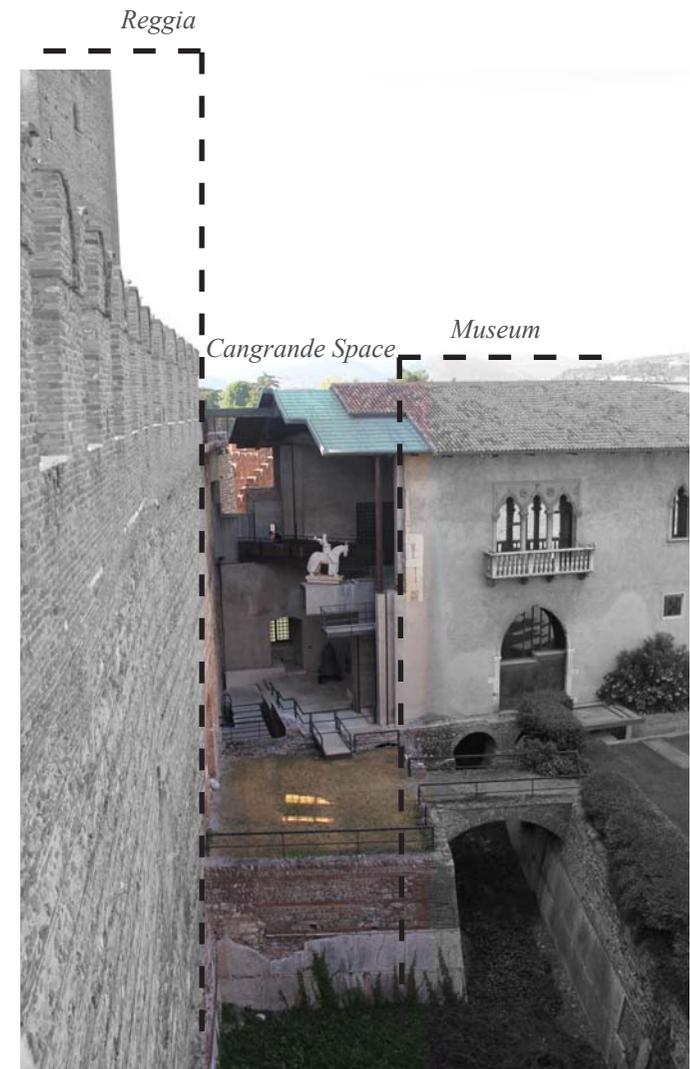
Fig 18 Image shows the cut between the Barrack Museum and the Reggia, The rediscovery of the moat, and the positioning of the Cangrande Statue

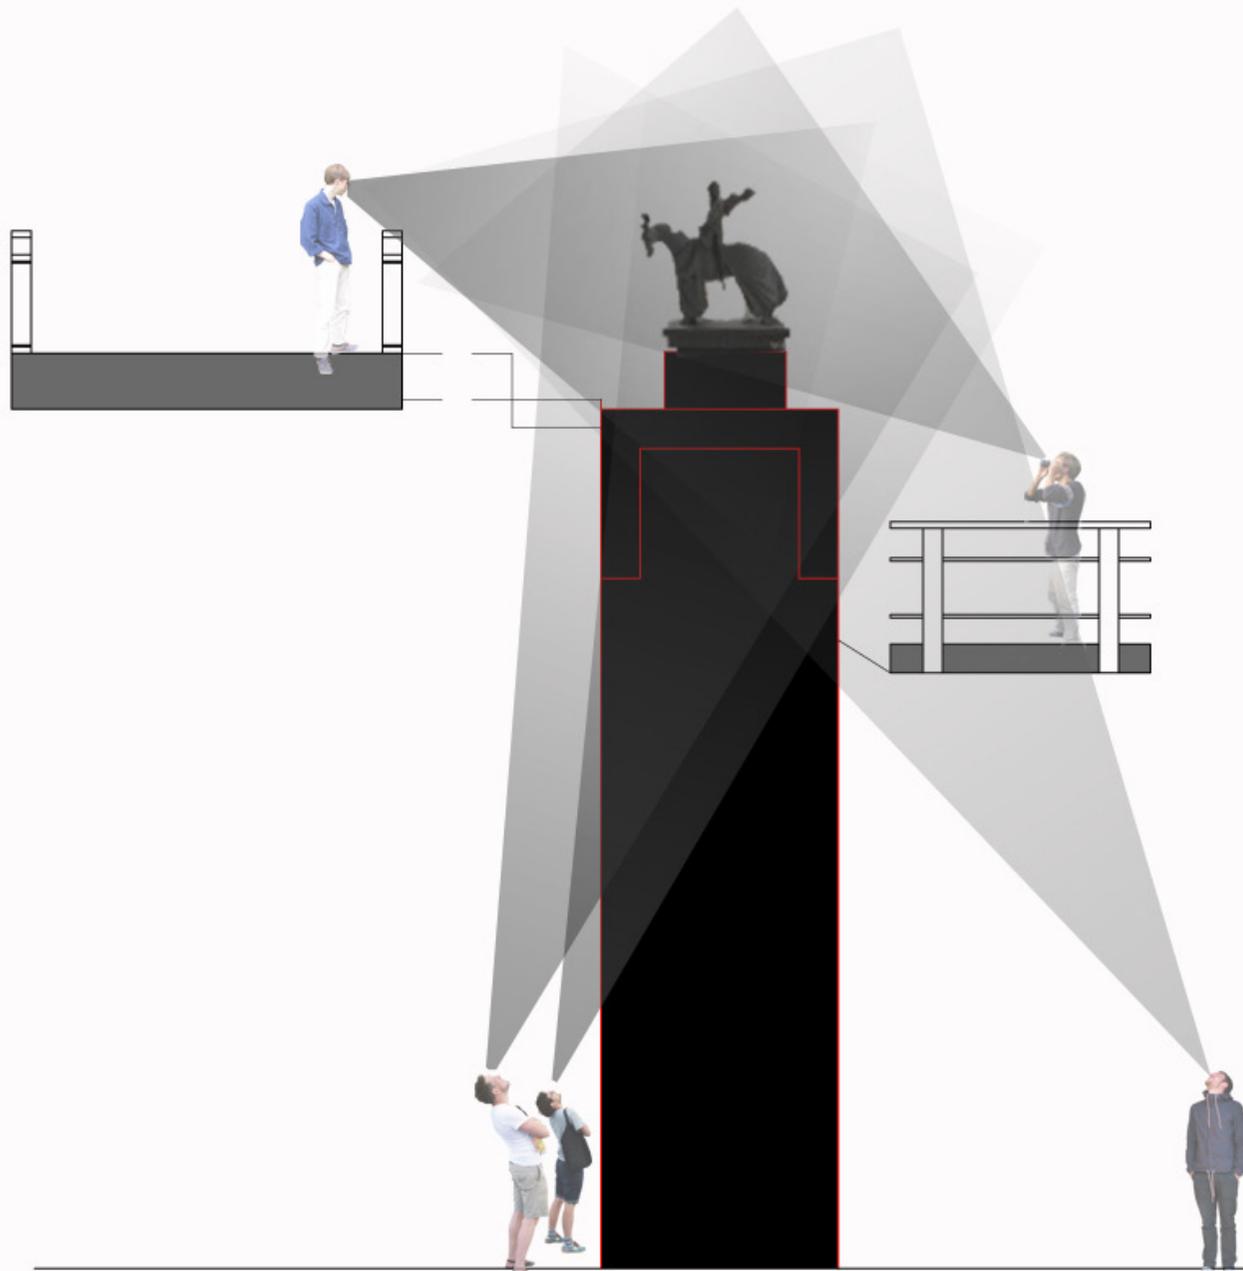
*Fig 23 The different views that can be seen of the Cangrande della Scala Statue from the Cangrande Space*

The main function of the ground floor space is for transition from the museum building to the Reggia. However, Scarpa used his techniques to create an experience of movement and designed views. These views cause visitors to pause briefly to read what they see - whether it be an archaeological mosaic layer, or a glimpse at the central focus of the space from below - the treasured Cangrande della Scala Statue of Verona. (fig 23 opposite page)

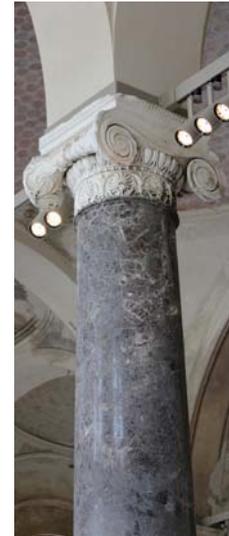
*Fig 42 Marble Column shows a varying level of decay consolidated*

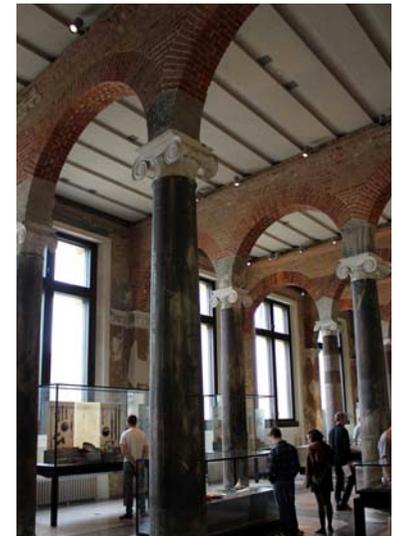
*Fig 43 Arcade of salvaged columns with reconstructed arches and a modern ceiling*

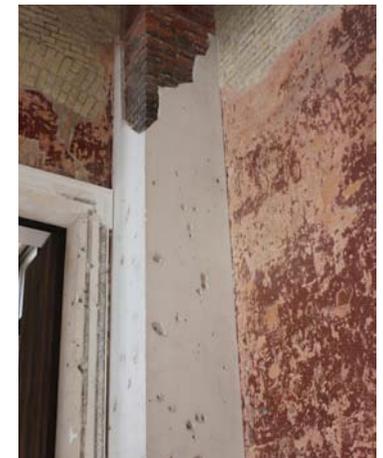
*Fig 44 damage, weathering and previous paint conservation are the layers of history retained by managing the decay*

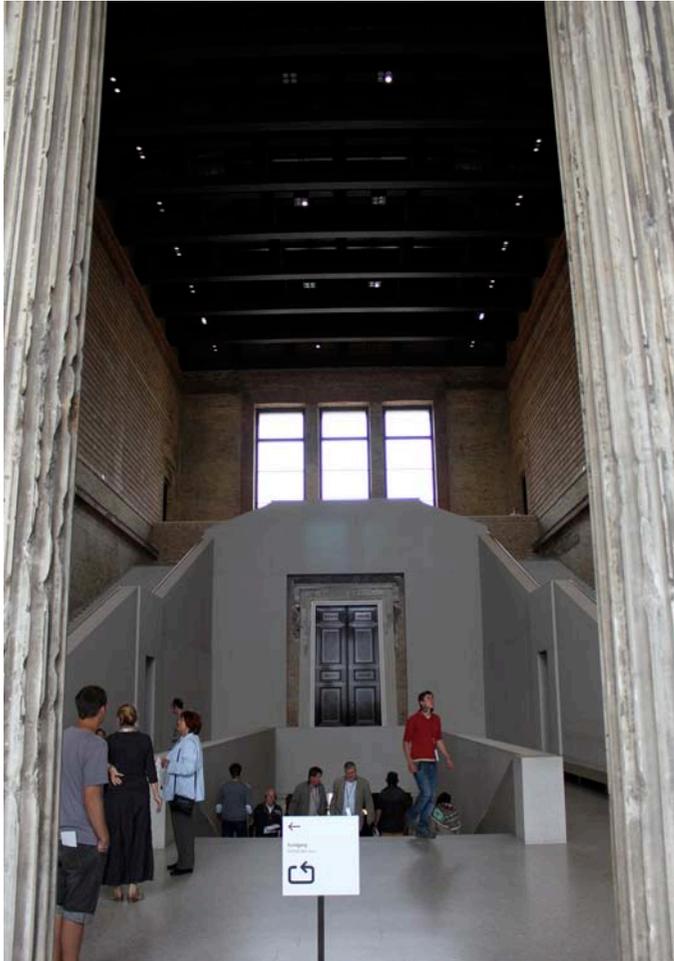
*Fig 45 The main staircase references the original staircase without replicating it. The large hall that is devoid of original ornamentation*

The building's central staircase was completely destroyed and is replaced with a modern intervention that forms a harmonious addition to the space. Constructed of precast concrete, the heavy and permanent sculptural aspect of the new stairway serves as a reminder of the lost form, and sits within a grand hall that is left in bare bricks. The same concrete that is used for the staircase is used throughout the museum, seaming together the gaps that occur within the fragments of the existing ruinous structure.

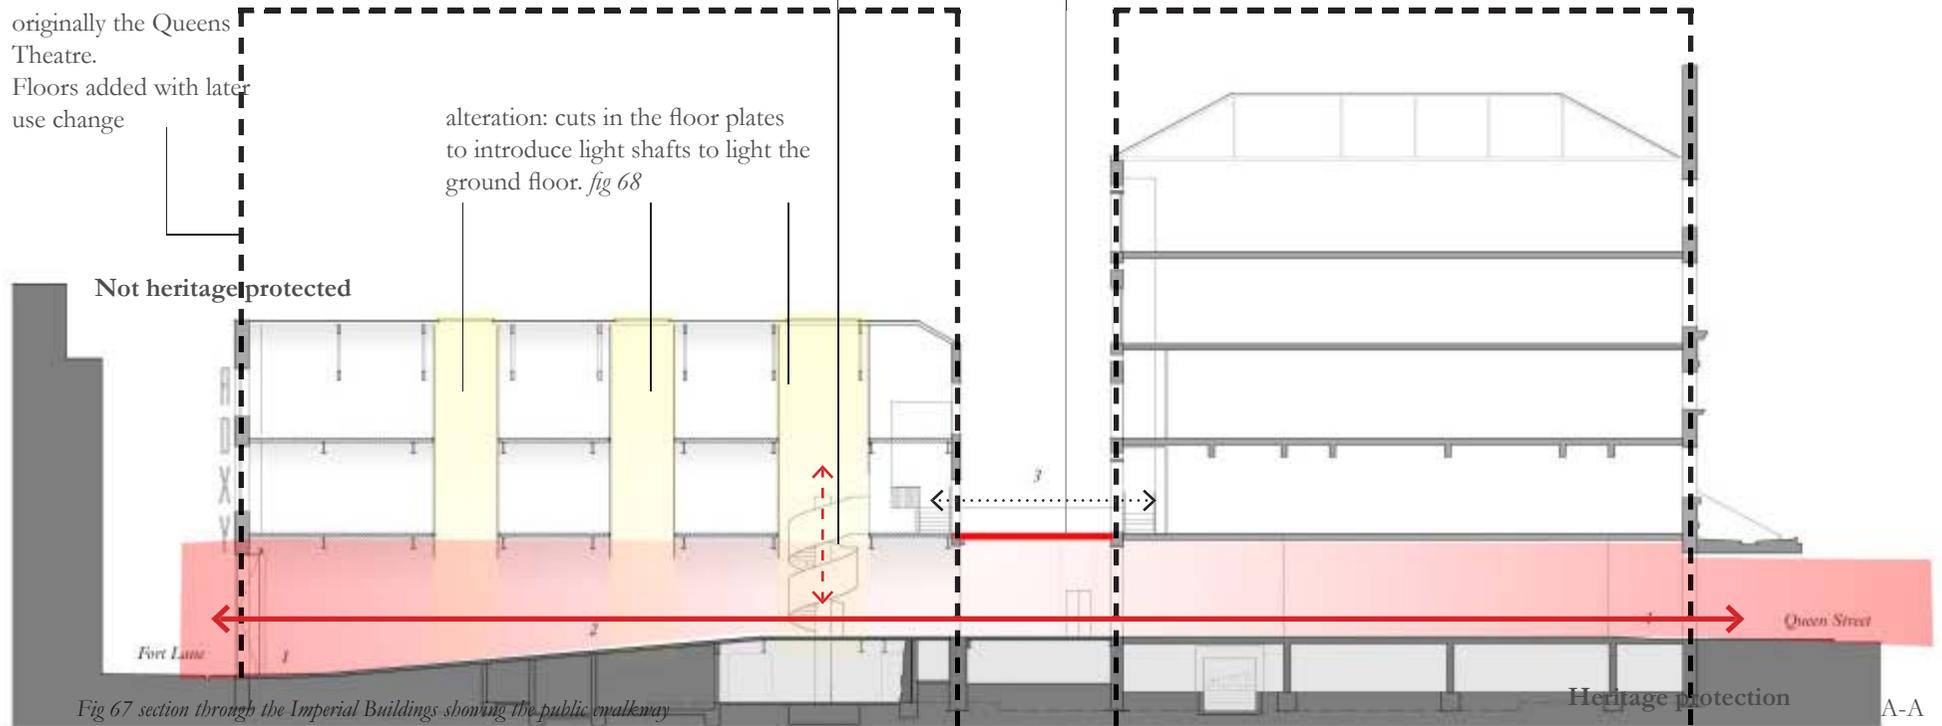
Fig 67 section through the Imperial Buildings showing the public walkway

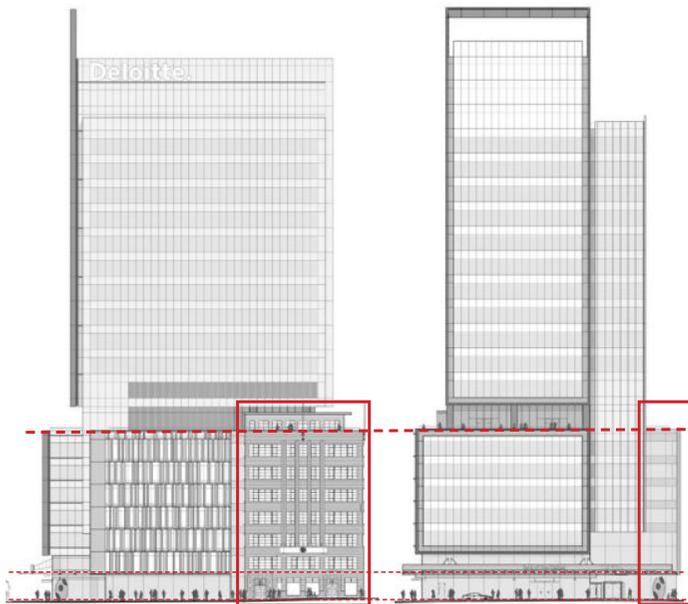
*Fig 74 shows the attempt to design the tower to incorporate and reconcile with the historic building by creating the first 6 floors of the tower to be extruded and follow the horizontal bands of the Jean Batten Building*

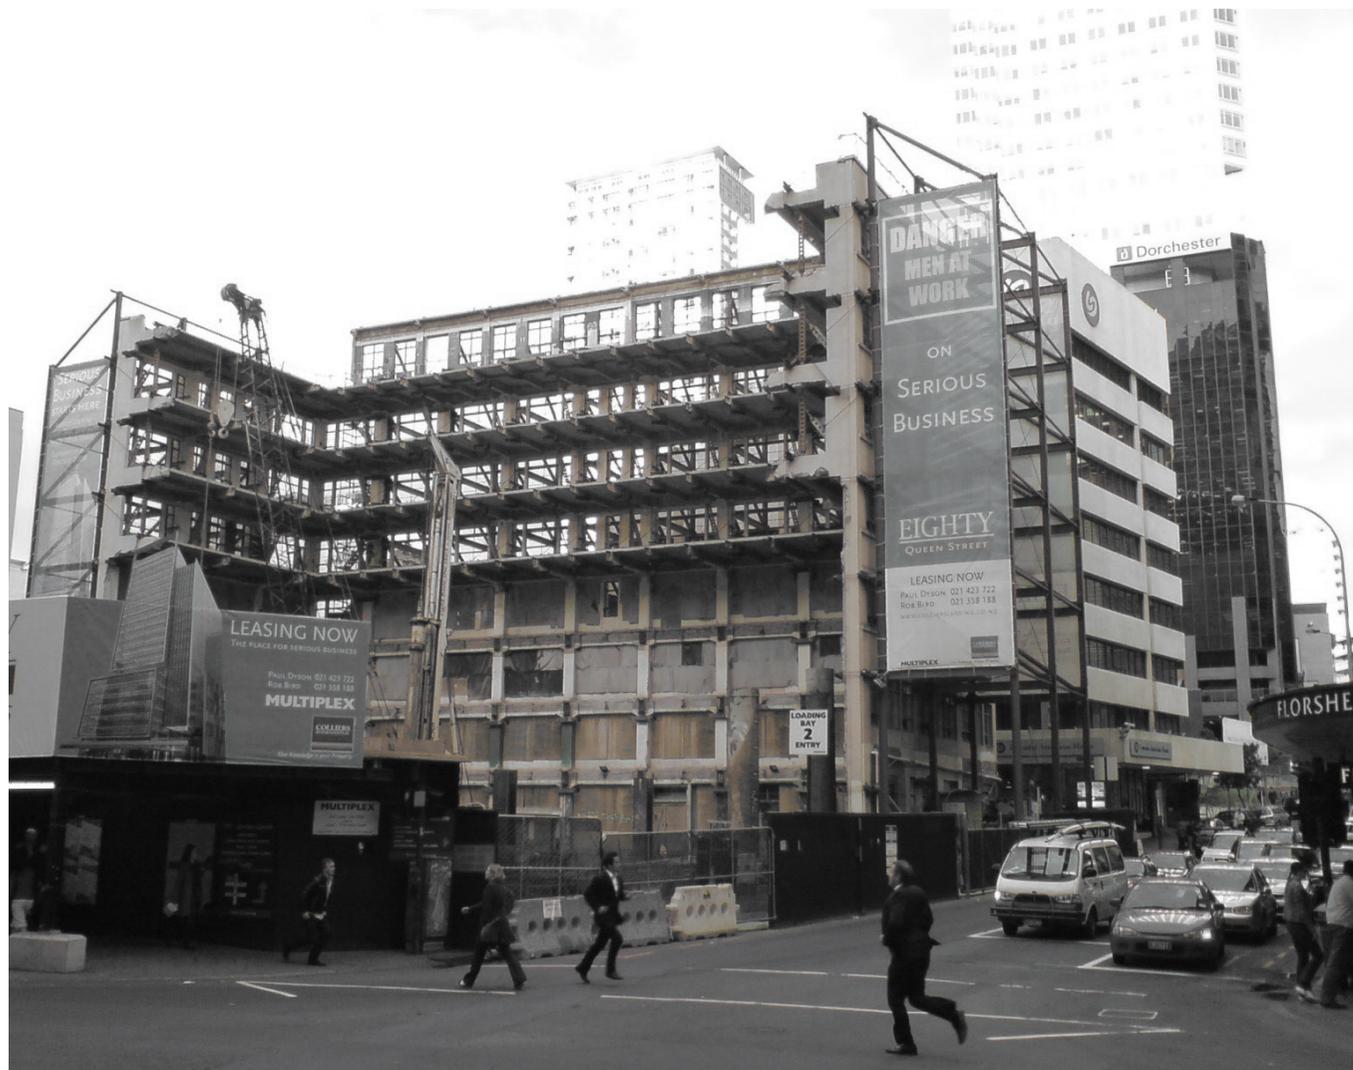
*Fig 75 Jean Batten building during demolition to create a footprint for the tower.  
Photo shows what was retained (the 3 facades with a 5m depth of each floor plate)*

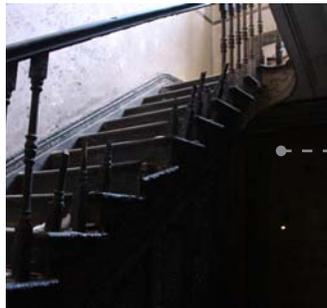
Fig 112 north-eastern staircase damaged by a second fire

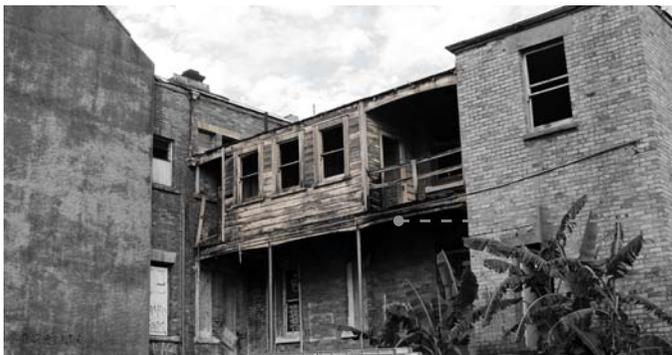
Fig 113 Fire damaged structure that was once the playroom for the Children's Home

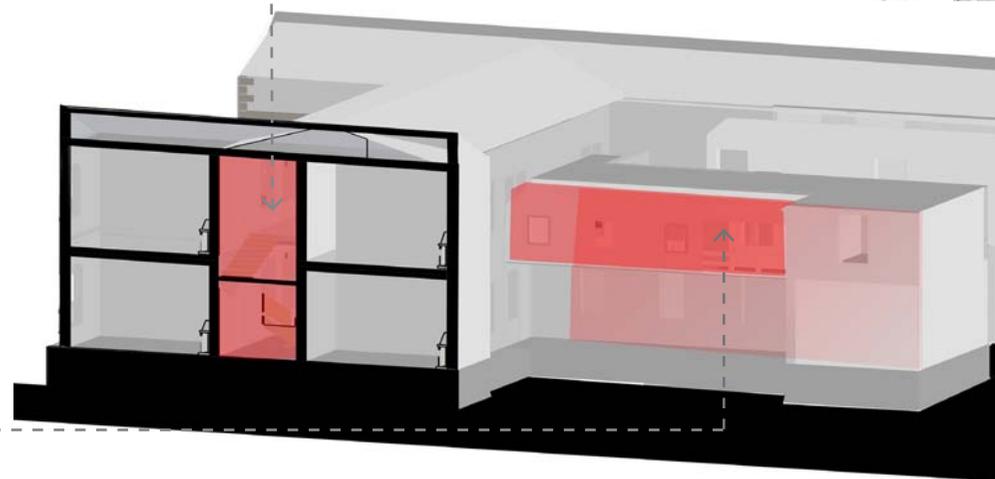
Fig 114 Diagram showing the fire damaged areas of the Carlile building

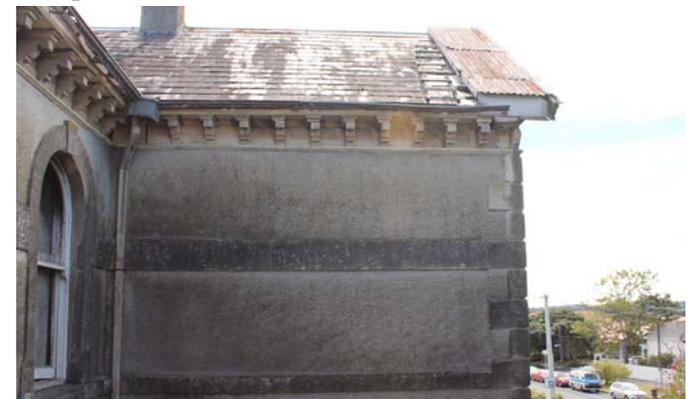
Fig 119 Tacky repair of the roof with corrugated iron

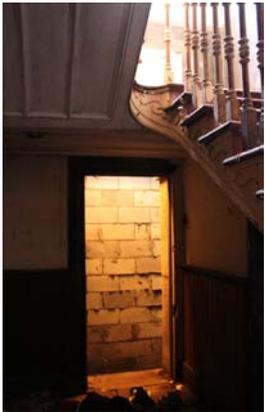
*Fig 127 south-east entry destroyed by the church*

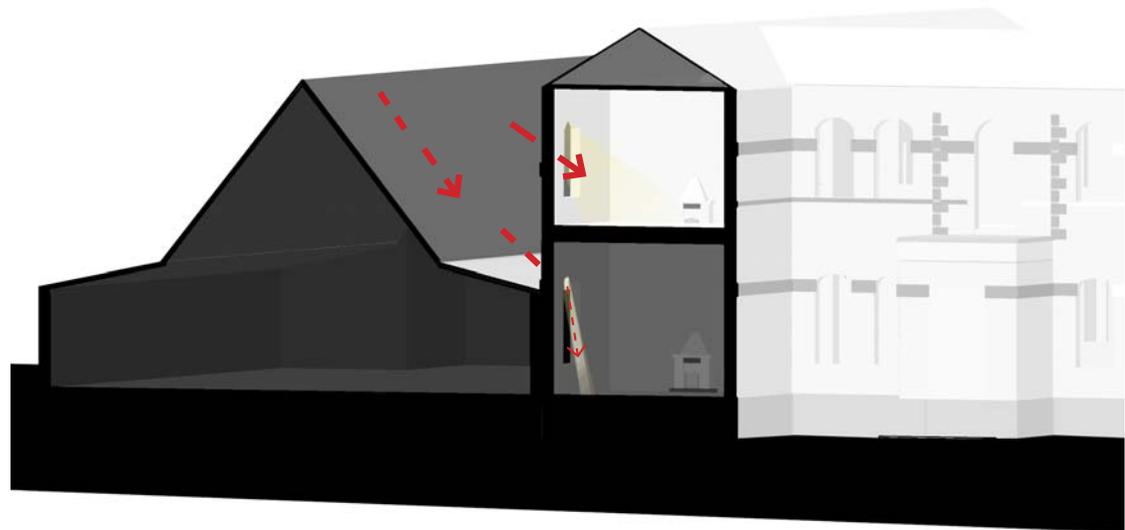
*Fig 129 diagram shows how the church affects light reaching areas of the Carlile building*

A constraint significantly impacting the Carlile building is caused by a neighbouring building (contextual impact): the Tongan Church. Initially, a smaller chapel stood separated from Carlile building, connected by a covered walkway from the south-eastern entrance. In 1979 when the United Church of Tonga renovated the chapel, the renovation extended to encroach wall-to-wall on Carlile building. This destroyed the south-eastern entrance that was in symmetry with the north-western entrance. It also inhibits natural light from flooding the ground floor of the south-eastern wing. The Tongan Church will be a challenge for the re-use design to find a solution to the devaluing impingement the church has on Carlile building. The design will need to address whether the church building (and the Tongan Church community) should be accepted and included in the re-use, or partially/completely demolished.

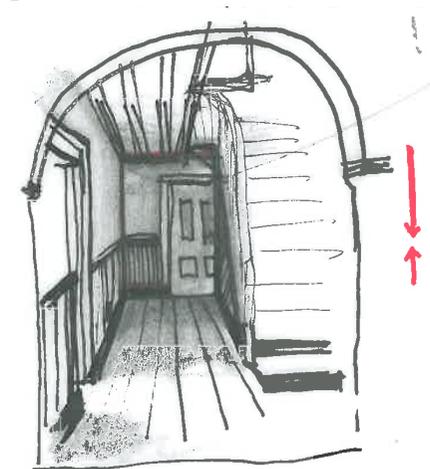
Fig 136 sketch illustrates large archway compressing the space beyond. The staircase compresses the view further. This causes the door to look small in comparison to these larger elements.

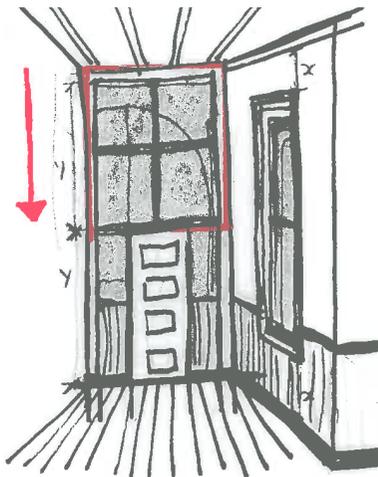
Fig 137 shows the oversized upper window causing the door to be perceived smaller. It is large and heavy in comparison to the door size and shape. This door and window placement segregating areas of the corridor relate to an institutional aspect of the building

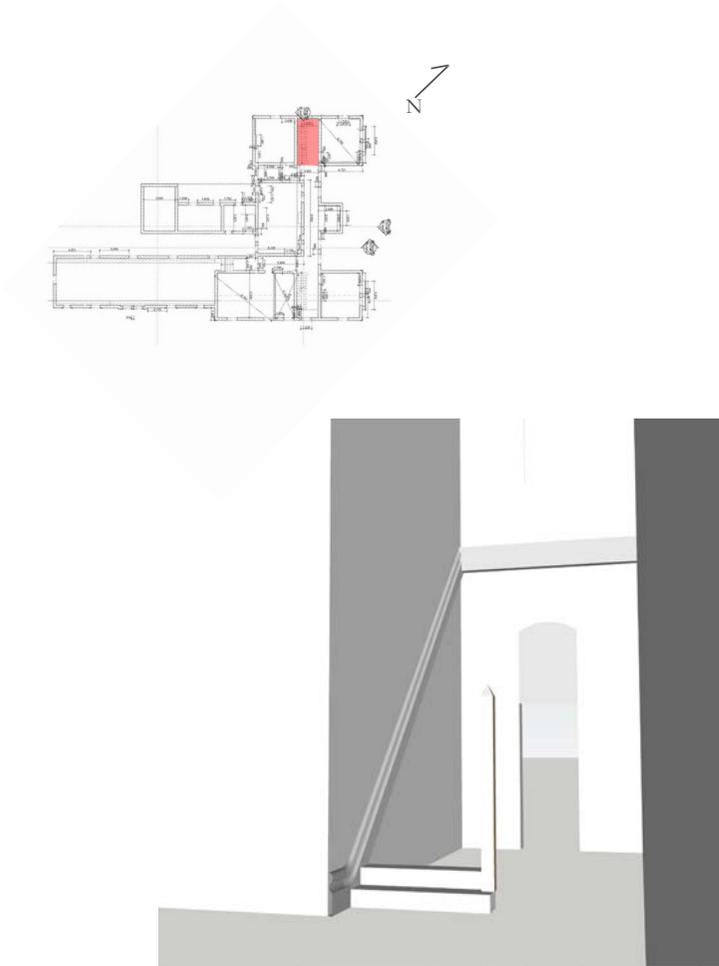
*Fig 142 Image showing an initial idea of removing the fire damaged staircase and leaving traces of what existed*

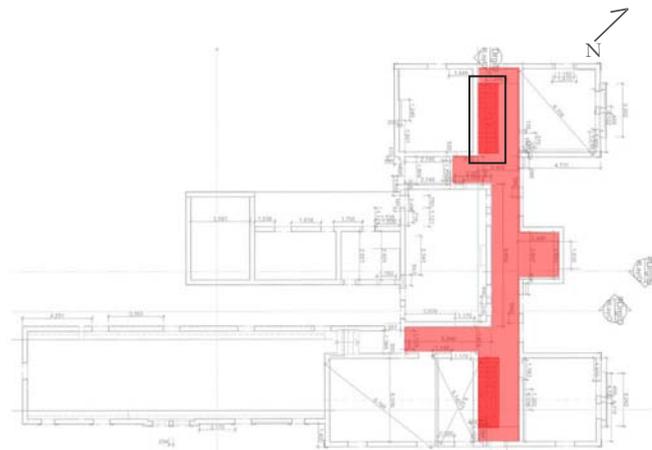
Fig 143 plan showing the symmetrical value (circulation) of the building

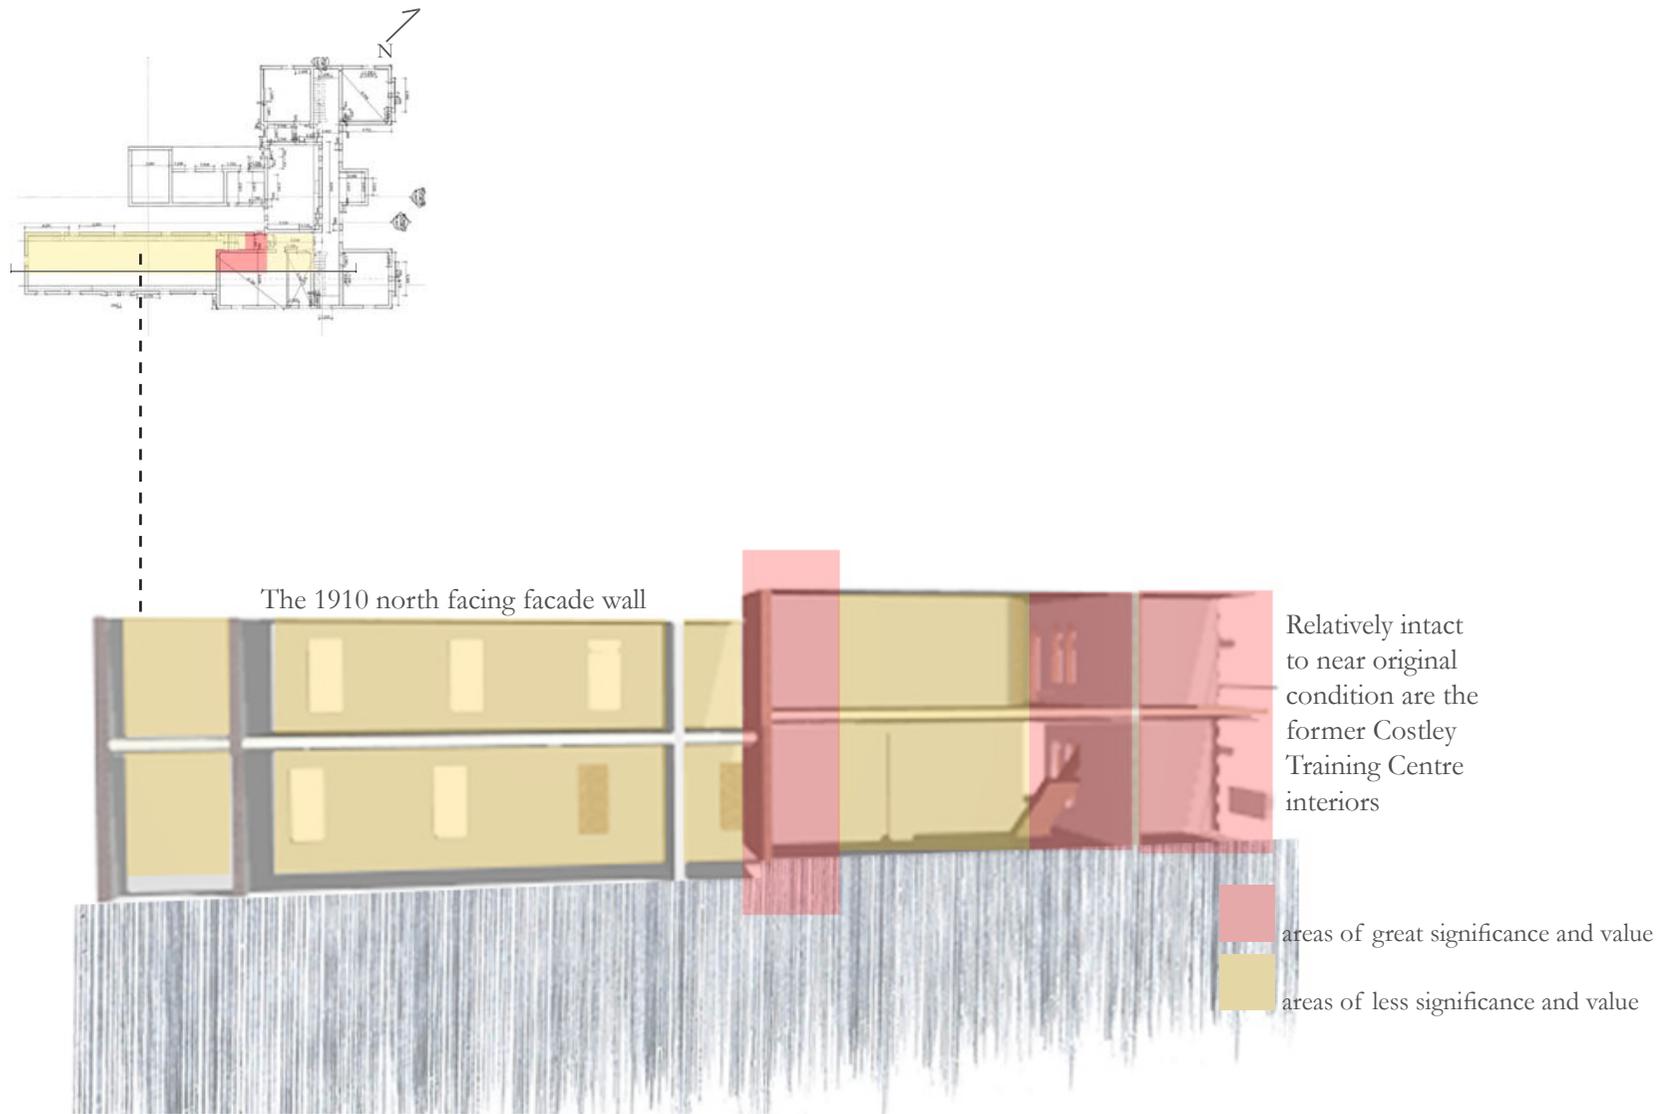
Fig 144 Diagram illustrating the value associated to the south wing of the Carlile building based on the understanding of heritage value.

A more informed understanding of value prompted an assessment of the areas previously mentioned that were caused by fire degradation (*section 5.11*). An alternative approach to the fire damaged stairs is to reinstate the space with a new contemporary staircase. This approach responds to the symmetrical plan of the building, acknowledging that the spatial (circulation) value of the building will be upset if the staircase is removed and not replaced (diagram illustrating this)

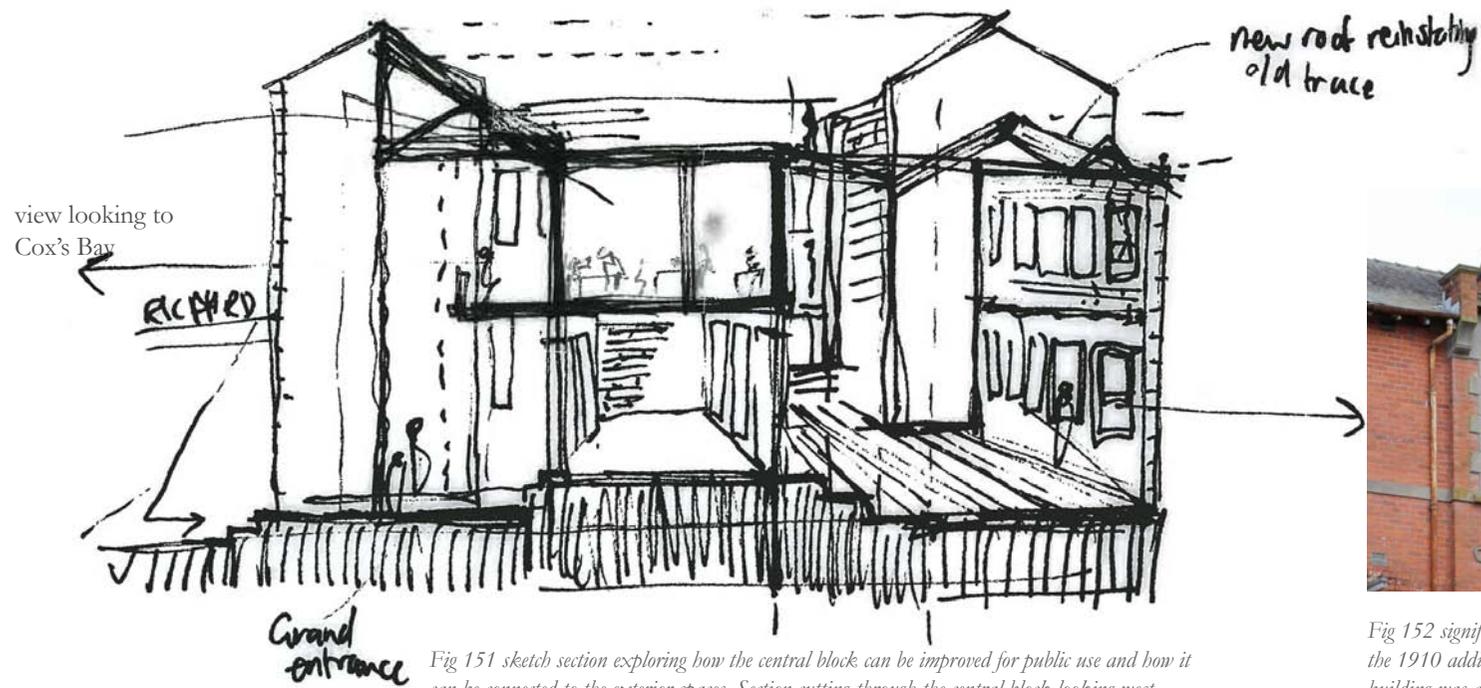
Fig 151 sketch section exploring how the central block can be improved for public use and how it can be connected to the exterior spaces. Section cutting through the central block looking west

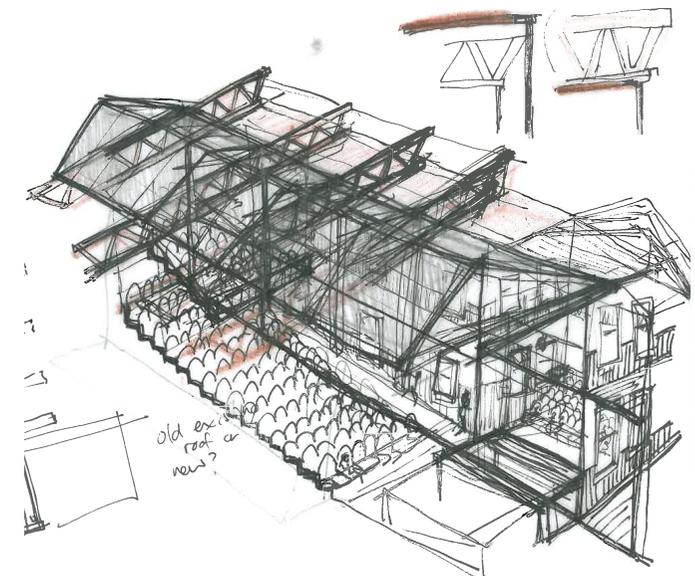
Fig 158 sketch illustrates a further progression of the theatre re-using the hearth. A new roof is added to the space.

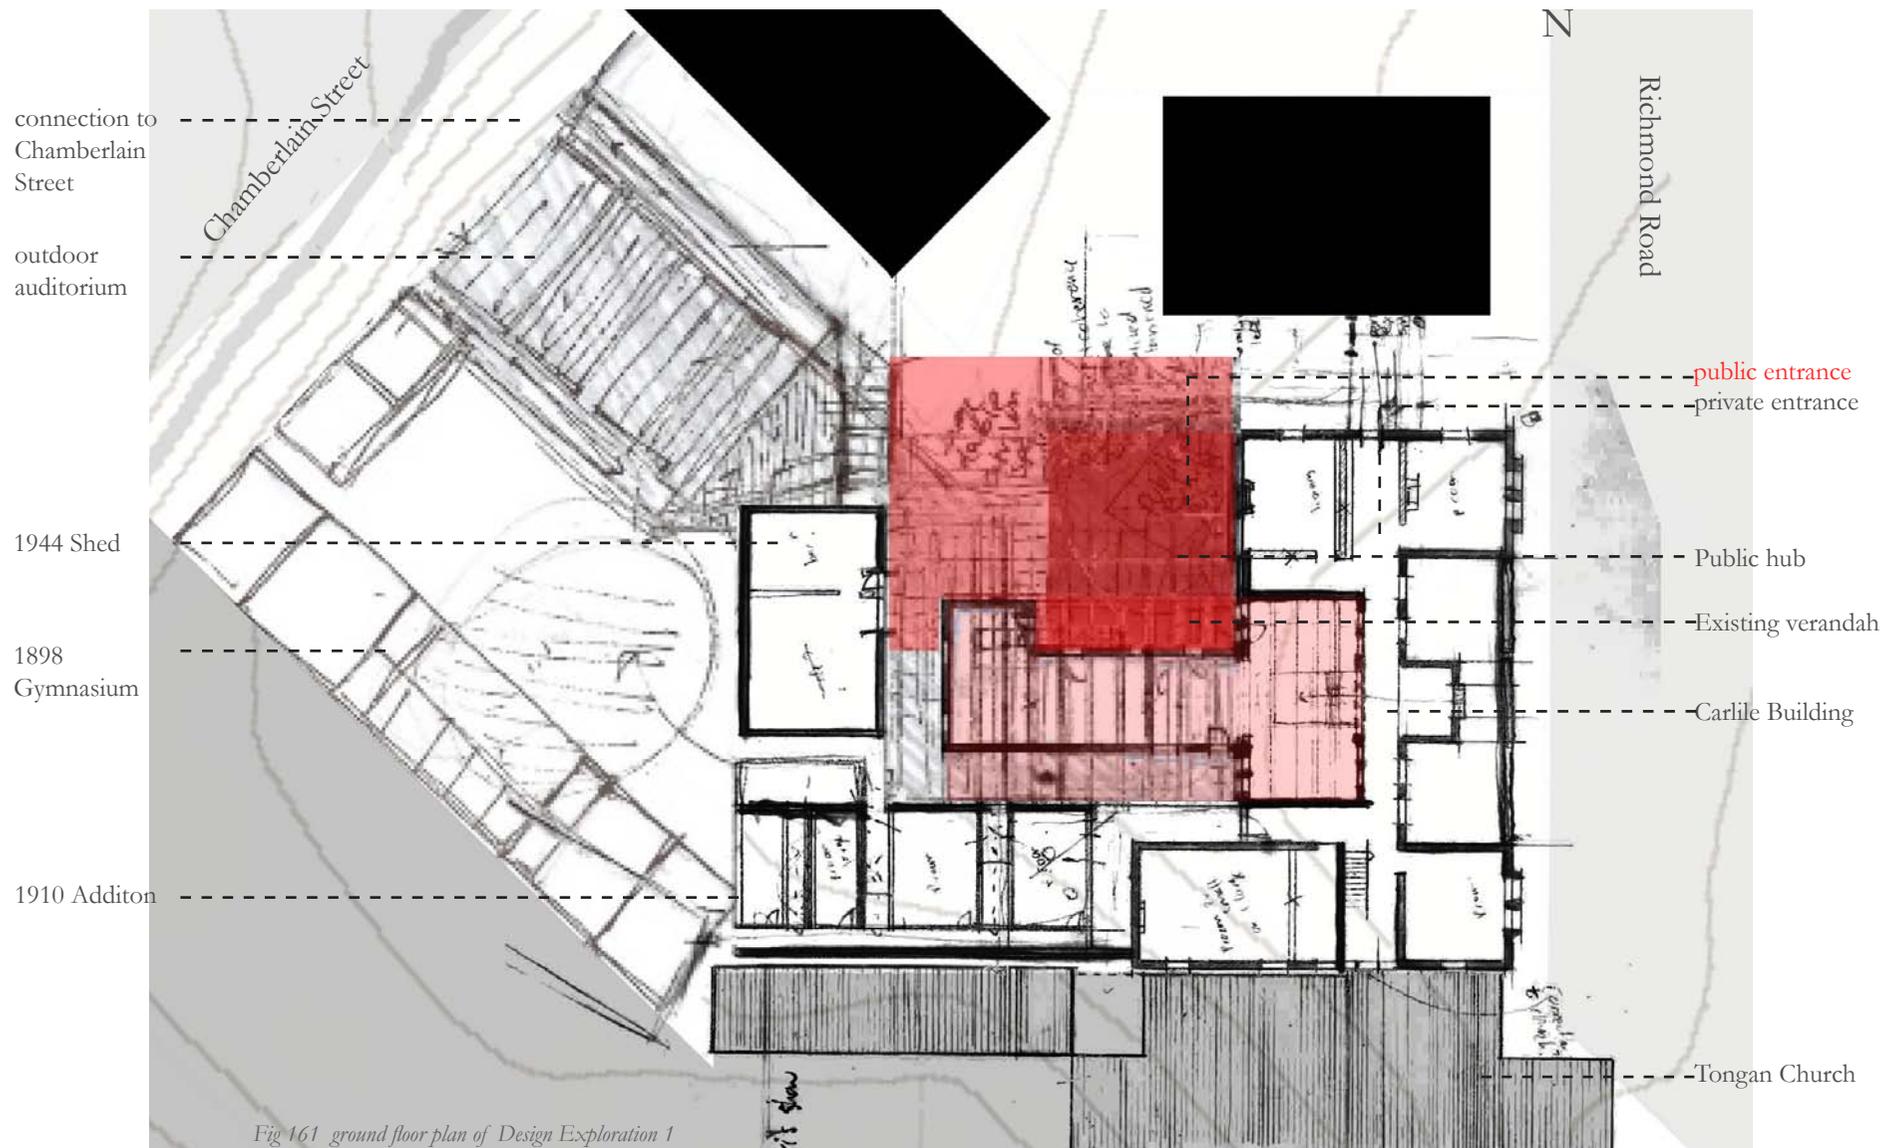
Fig 161 ground floor plan of Design Exploration 1

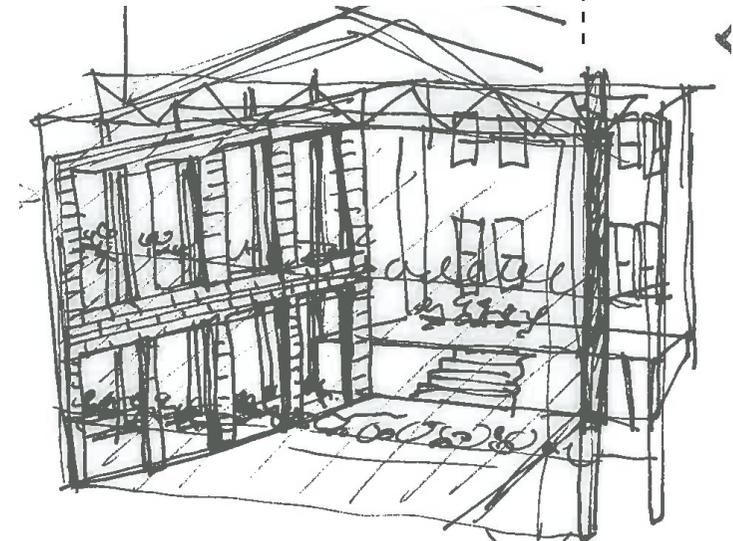
*Fig 163 sketch explores ways to extend seating space by creating a series of protrusions within the exterior wall of the central block. These act as view holes to the stage but this would be unpractical and problematic*

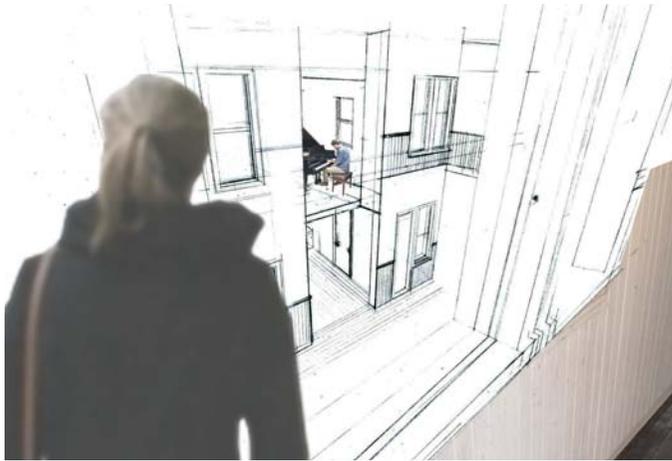
Fig 164 removed floor of the hearth to create a double height space

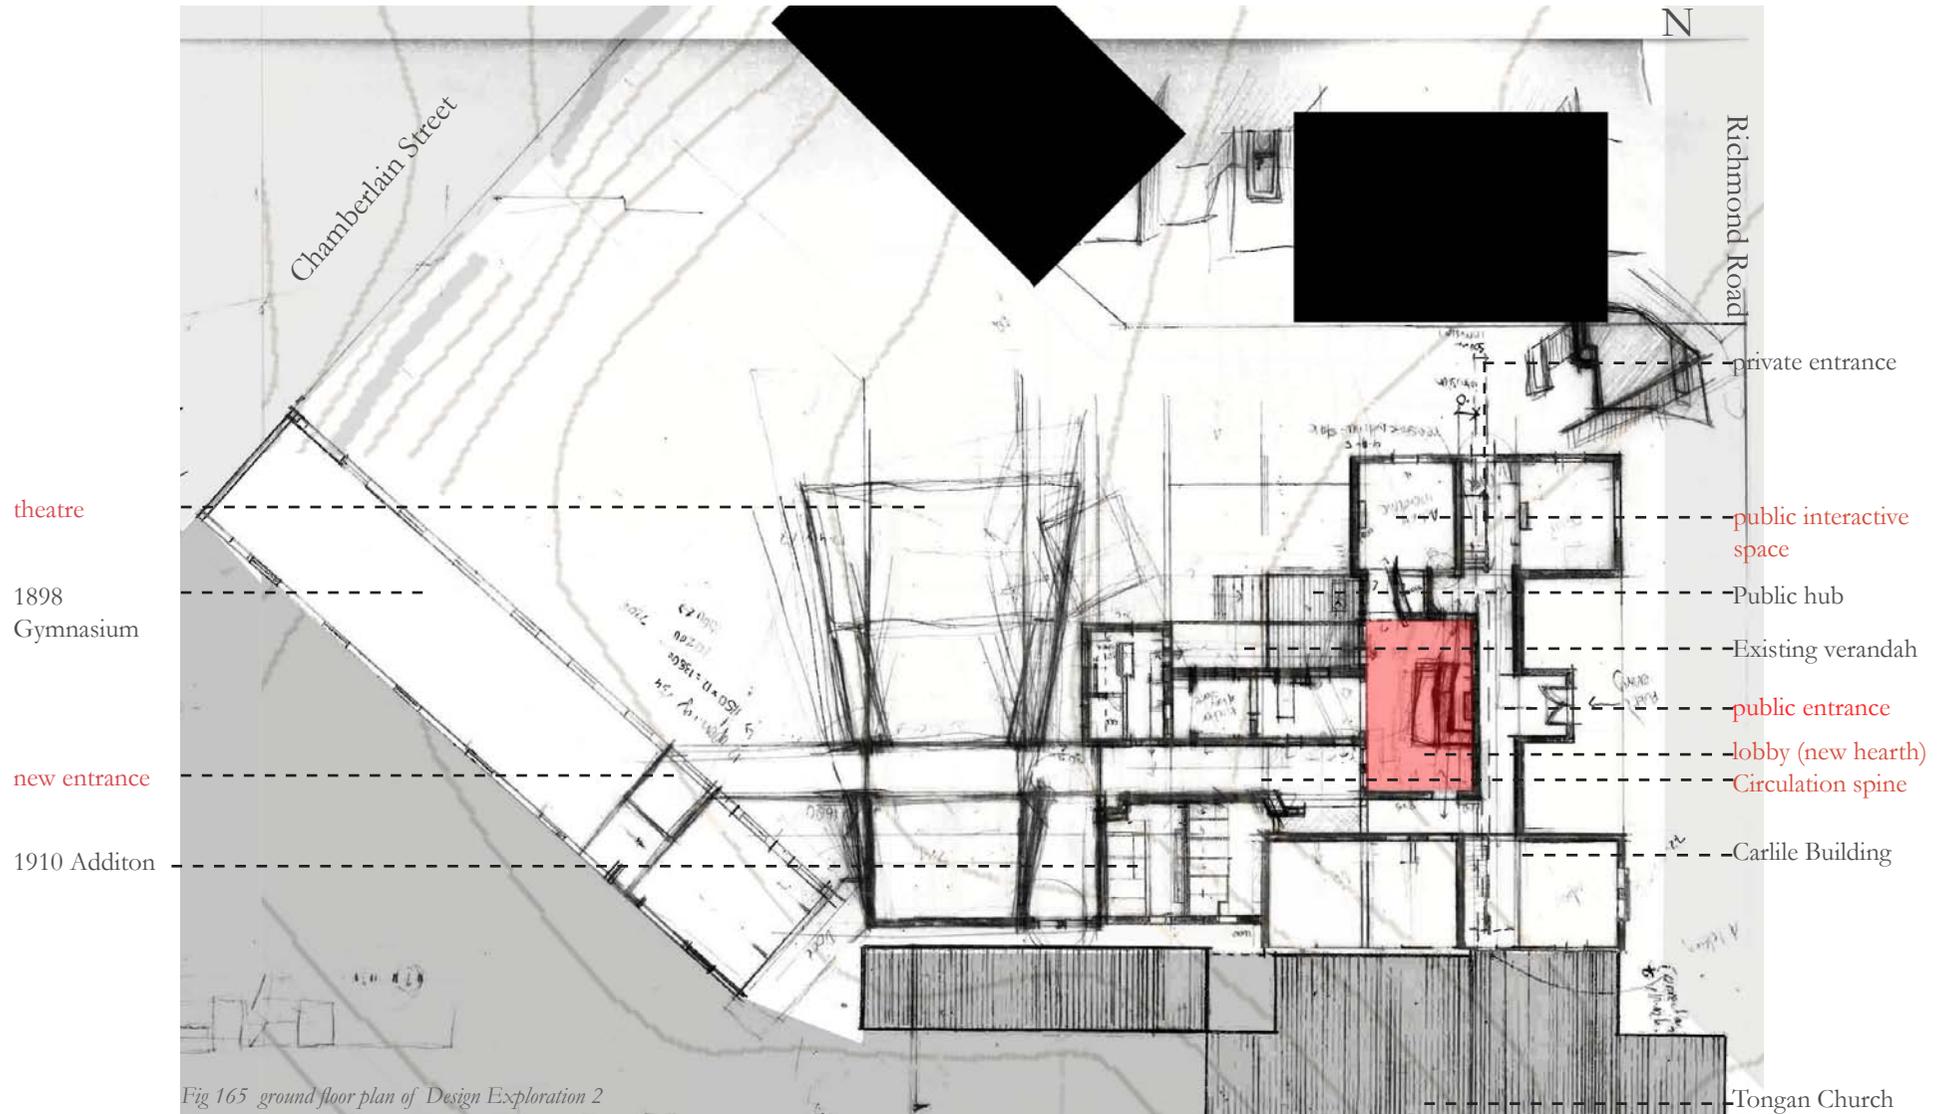
Fig 165 ground floor plan of Design Exploration 2

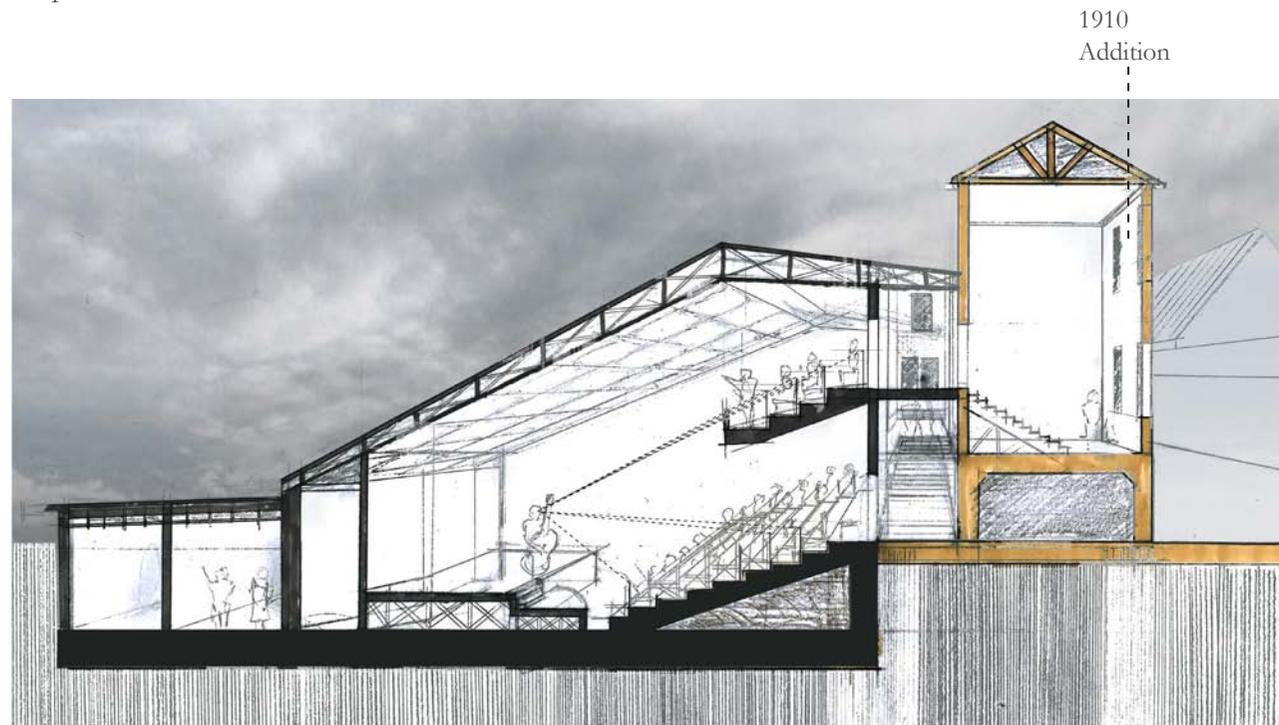
*Fig 175 Section through the Theatre*
