Sekai Walls  
ID: 1254661

Master Thesis explanatory document  
Dr. Christoph Schnoor & Tony van Raat

An explanatory document submitted in partial fulfillment of the requirements of the degree for the Master of  
Architecture (Professional) at Unitec, New Zealand 2013.

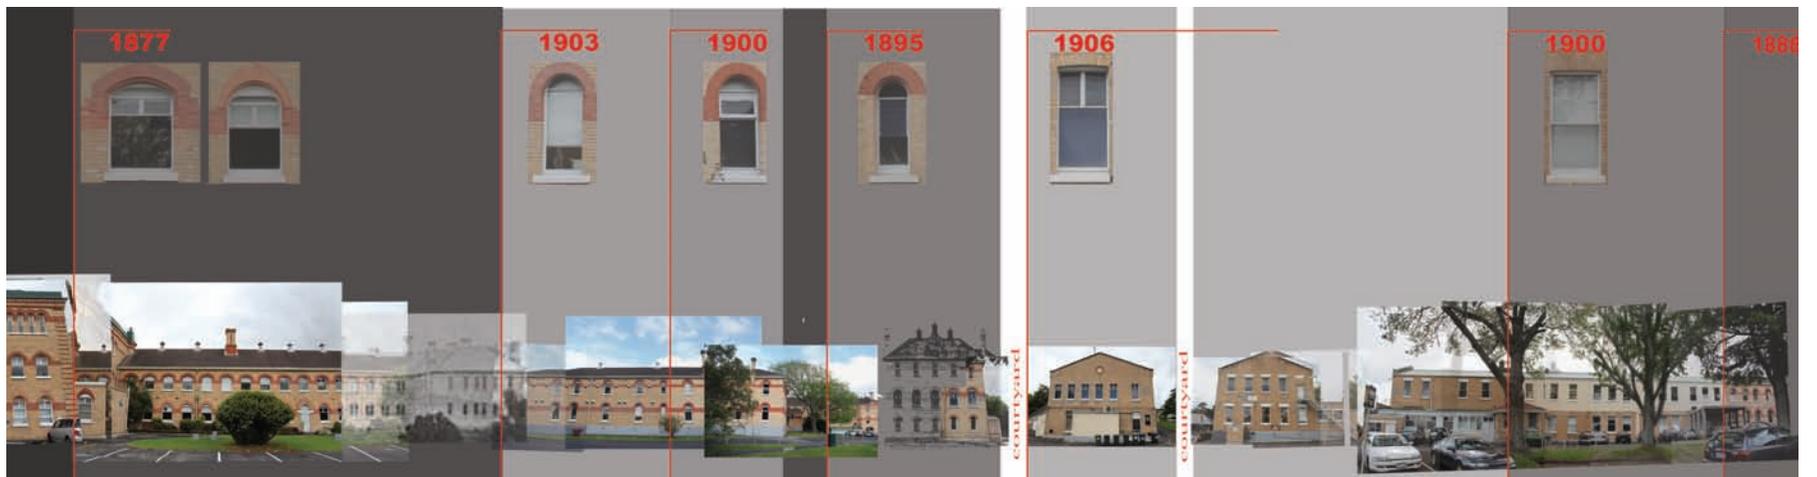
Fig 183 window forms have remained respectful of the original over the building's developments

The placement and design of the windows of this historic building have allowed the windows to become predominately the most valuable object of the exterior. The windows show the buildings development, suggests to public that it is a important and significant building, and they break up the facade, helping the building to not look too overpowering and intrusively its landscape.
