## Lyllall Bay Coastal Remediation

### Abstract

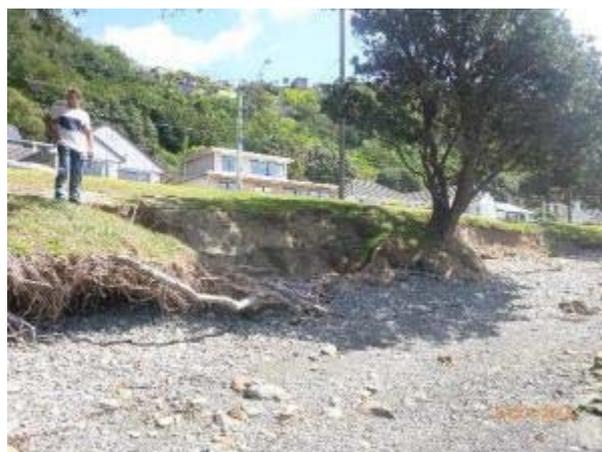
Figure 2 The retreat of the coast in the northern section of Dorris Lesley Park has resulted in a scarp of up to 2 m in height and now several Pohutakawa trees are at risk of being completely undermined and falling seaward.

The purpose of this project is to propose options for Lyllall Bay with regard to protecting the natural and built coastal infrastructure and reinstating a functioning dune (Figure 2). The aim is to retain as much beach and dune amenity, access and parking, provide defence for the road, footpath, structures

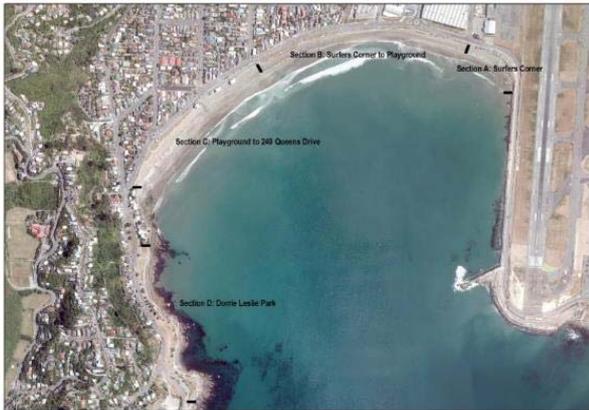
Figure 3 Aerial of Lyall Bay showing the 4 sections.

Lyall Bay was divided into 4 areas of interest to address (Figure 3):

1. Section A: Surfers Corner carpark
2. Section B: Surfers Corner to playground
3. Section C: Playground to 249 Queens Drive
4. Section D: Dorrie Leslie Park

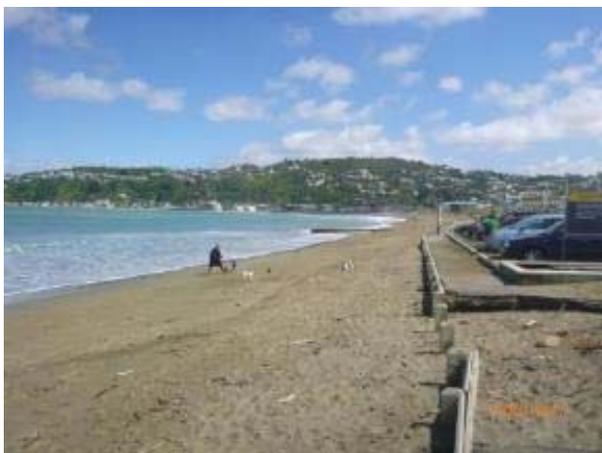
Figure 4 Lyall Bay beach showing carparking, no dune and a stormwater outfall.

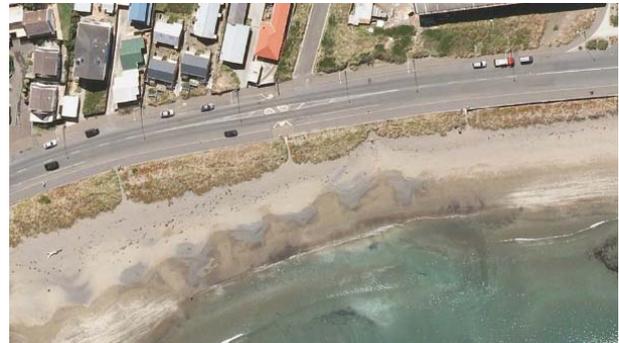
Figure 9 An aerial perspective of Lyall Bay showing the straight access pathways and an example of the erosion cut caused by discharging stormwater above the high tide mark. Paths through the dunes can also be seen; foot-traffic damages dune plants and so reduce resilience of the dunes.

options to protect the rocky shoreline, grassed area and trees on the western side of the bay; and options for the shifting of sand around the bay and dealing with current infrastructure within the beach environment (Figure 9).

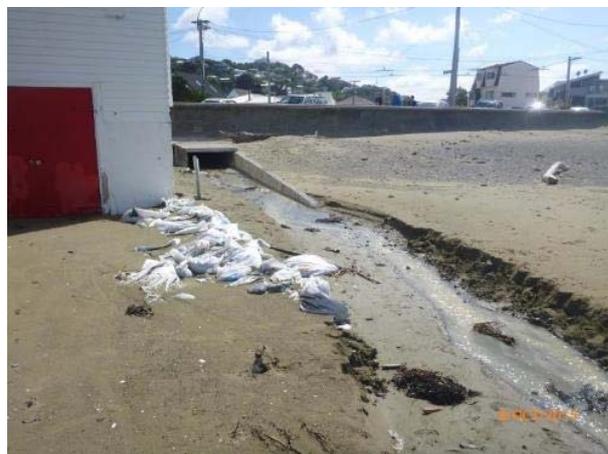
Figure 10 The stormwater outlet next to the Maranui SLSC is one of the most troublesome in Lyall Bay; it outfalls at the base of the seawall (i.e. is the more landward than others), is very close to the building and has a relatively high discharge rate compared to others. Burying and lengthening to the intertidal zone will reduce the negative impacts on beach stability and amenity.

An assessment was undertaken on the present condition of stormwater infrastructure on Lyall Bay beach (Figure 10), and remediation required (e.g. outfalls, pipelines, pipeline outlets, manholes, etc.). The stormwater outlets along the dunes, above the high tide mark appear to erode the beach and likely prevent sand accretion due to liquefaction. The results are ranked according to impact and effect on coastal processes, and the effectiveness of the outfall as a stormwater outlet. This will provide the council and community with options for future prioritisation and timeline, as well as budgetary planning (from short to long term). In particular council has requested information on:
