## Structural Quality Control in the Field.

### Abstract

The quality control of structural elements for post disaster reconstruction in the field is problematic. Test facilities are often remote, training can be inadequate and the attitude of suppliers and contractors can be negative towards such controls resulting in less than adequate construction. This paper outlines several techniques that have been used to address such issues that included of the following:

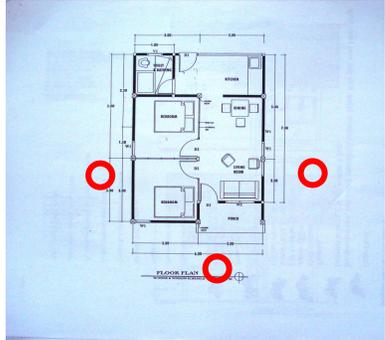
Structural Quality Test	Test Locations
<p>Scala Penetrometer</p> <p>3 tests per house ( 1 on each side and 1 in the front)</p> <p>Bearing capacity at the founding level of the pads required. Test to 1.0 metre below footing.</p> <p>Note water table depth.</p>

Insufficient soil bearing capacity at any one of the 3 test locations constituted a fail and a recommendation to demolish regardless of the other test results. If that was not the case then the house needed to achieve at least 3 passes from the 5 test locations for the remaining 2 tests to pass.

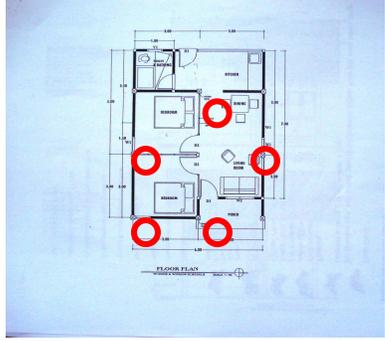
<p>Rebound or Schmidt Hammer Testing</p> <p>5 tests per house on the 200x200 columns are shown in the plan. Tests to be around 300 mm above floor level and in the core of the column. Testing should be to the concrete rather than plastered finish.</p> <p>Take 5 readings minimum at each test location. Record readings in MPa units</p>

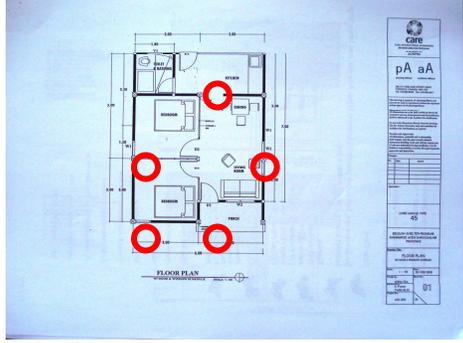
Table 1: Test locations.

<p>Cover meter</p> <p>5 tests per house to confirm the size of the vertical rebar and the cover of the 5 200x200mm columns indicated on the plan.</p> <p>Record the outside to outside distance between vertical reinforcing in the indicated columns.</p>
