After the rot: Improving the Durability of Building Envelopes in Domestic Housing, New Zealand.

Chris Murphy MArch ANZIA

Department of Architecture
Unitec Institute of Technology, Auckland, New Zealand
e-mail: cmurphy@unitec.ac.nz

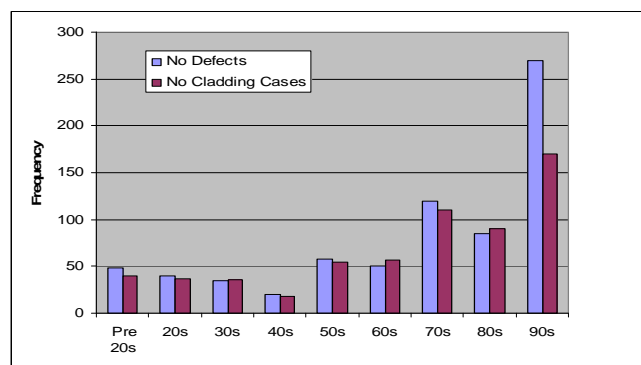
Figure 1: Defect v Cladding Cases

These societal factors had outcomes in terms of building performance. Deficiencies in the external building fabric continued to become apparent as inquiry and debate over the quality of construction intensified. In 2001 a report by the writer commissioned by the BIA [2] that surveyed some 287 pre-purchase reports indicated some 60% of the dwellings inspected let in moisture through the cladding to an unacceptable degree. Whilst buildings in New Zealand had always led to some degree (NZ is a coastal climate and capable of extreme climate variation) what was different and new and picked up by the survey, was the significant percentage increase in cladding systems letting in moisture compared to the number of cladding cases constructed in the period following these societal changes and the introduction of the National Building Code in the 1990s. (Fig. 1)

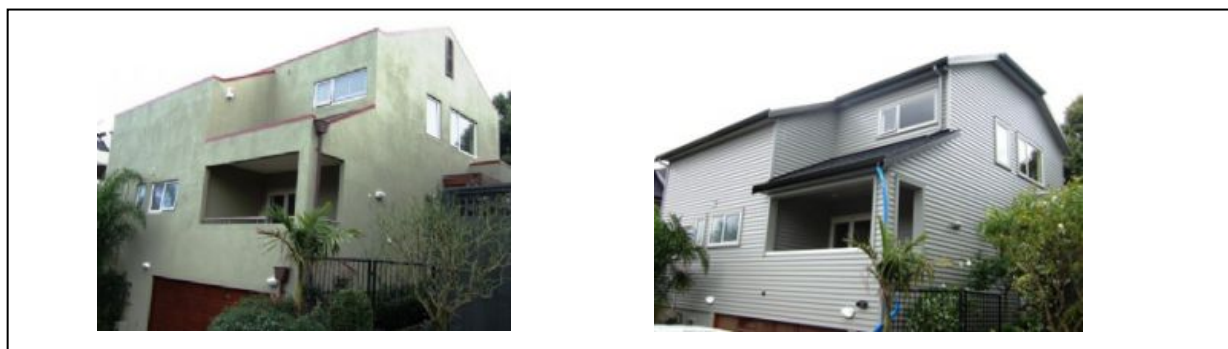
Figure 2: Reliant Group. Before and After Re-cladding Examples [9]

How specialist is the “specialist.” Most rely on web promotion and advertizing with client references, membership of building organizations, testimonials and completed projects (Fig 2) to back up their claim as competent. The formation of a self monitoring collective or association of approved operators within which critical reflectance and a forum for continuing professional development can occur would be the logical next step in ensuring the body of knowledge gained in this specialist work continues to grow and be disseminated to as wide an audience as possible.

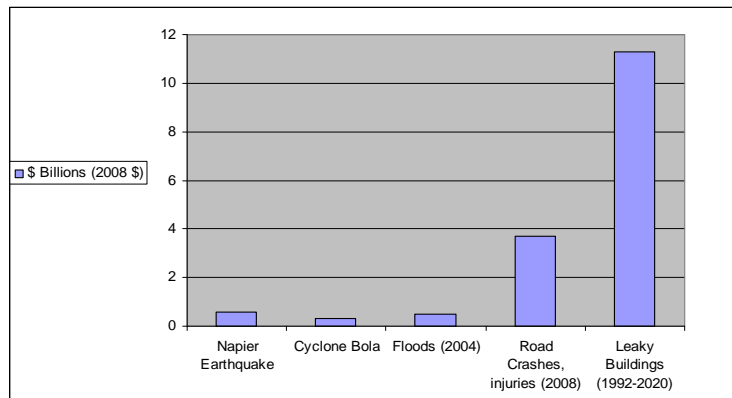
Figure 3: Covec Ltd. Cost Comparisons [10]

To this end, the recently completed government initiated Price Waterhouse Cooper's report [12] on estimating the cost of the weathertightness problem paints a depressing picture of escalating numbers of effected buildings that dwarfs the estimates of earlier years. The recently completed Covec report has even compared the problem to a scale of disaster in 2008 terms on a par with the Napier earthquake. [10] (Fig 3, Table 1).
